River Corridor Closure Project

Recovery Act Weekly Report

For the week ending June 3, 2011

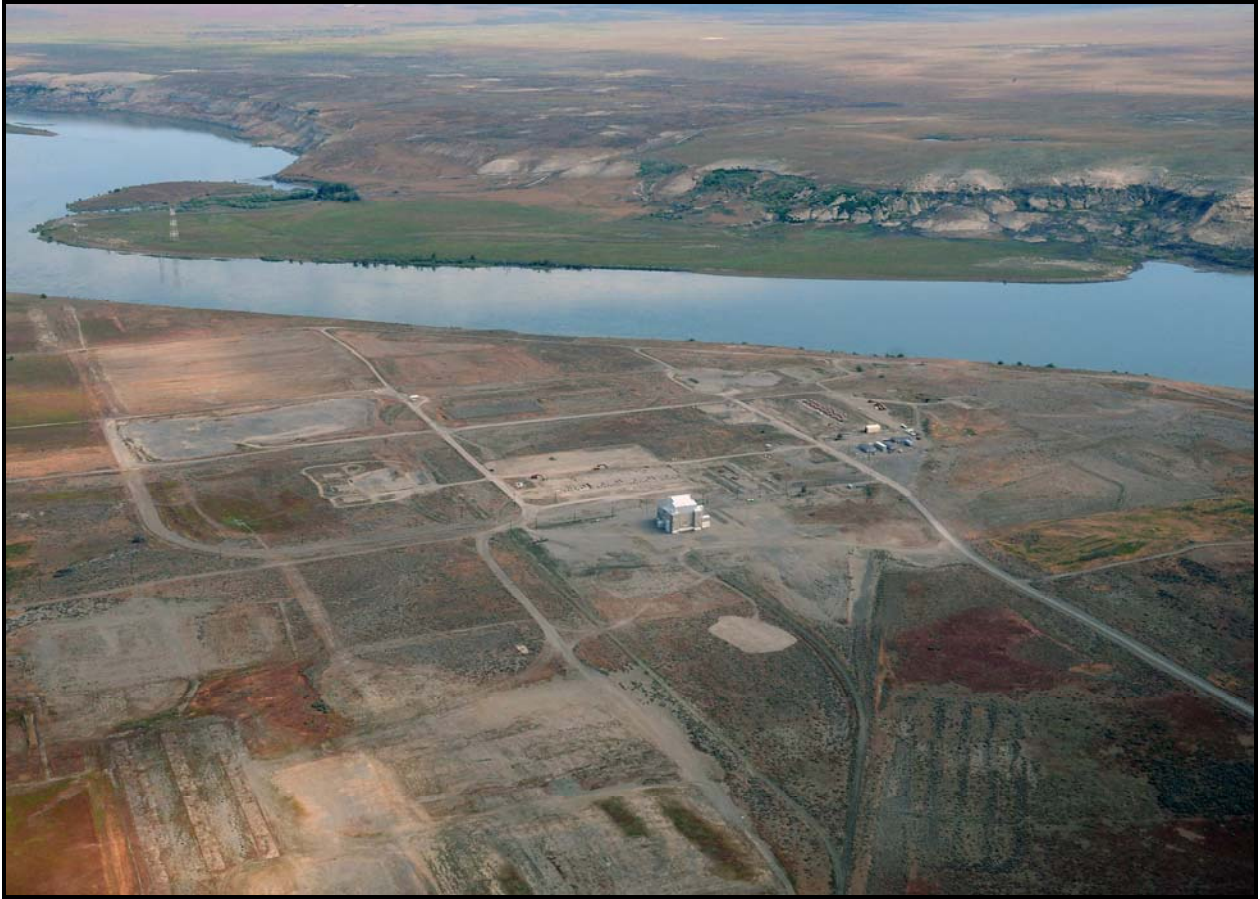
Washington Closure Hanford is remediating 19 waste sites in 100-F Area, home to the third of Hanford's nine plutonium production reactors. (Photo 10)

WCH and subcontractor Ojeda Business Ventures continued with the remediation of 19 waste sites at 100-F Area. The project team is demolishing and loading out the western portion of 100-F-57 to the 15-foot level. The site consists of stained concrete and soil containing hexavalent chromium.
