River Corridor Closure Project

Recovery Act Weekly Report

For the week ending July 22, 2011

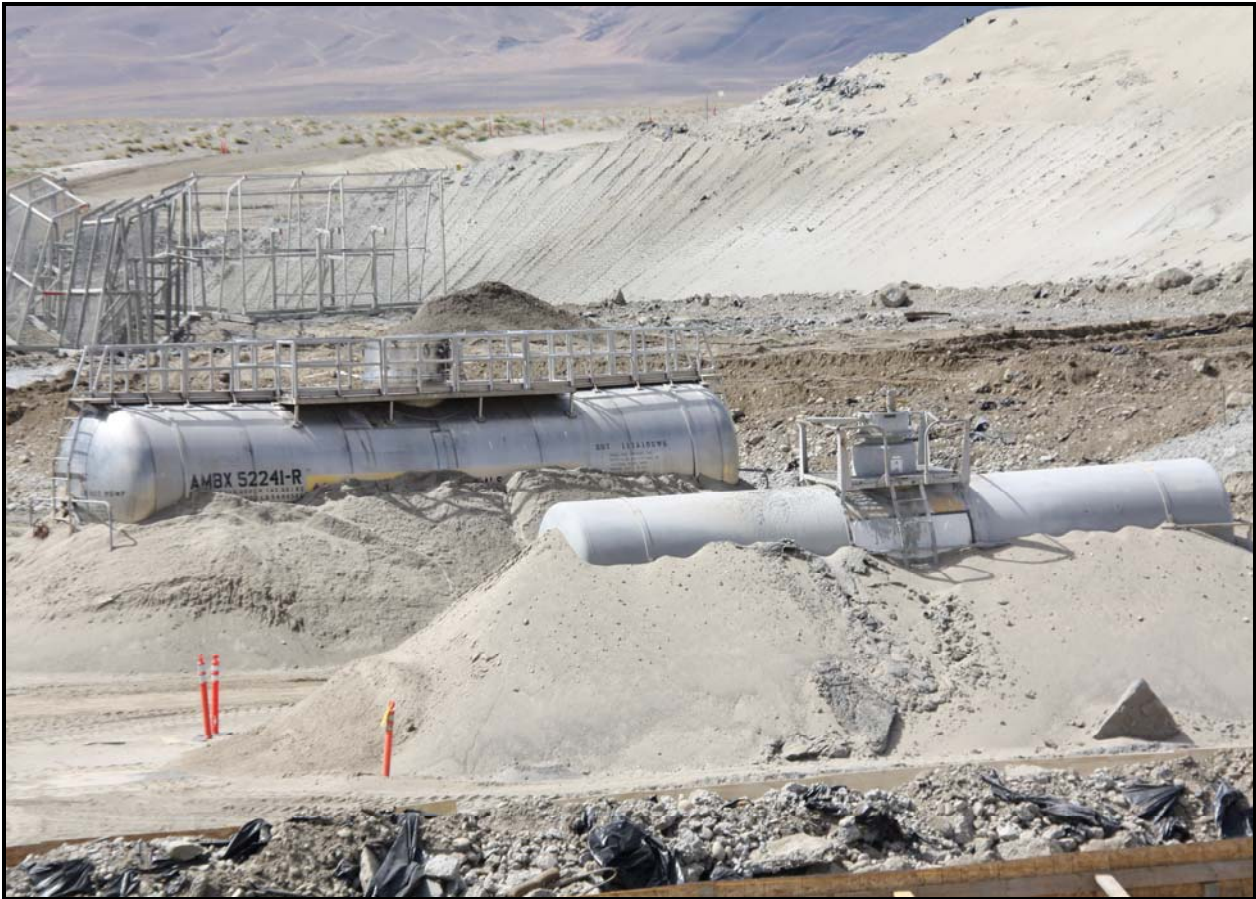
Two Hanford Site tanks cars are being disposed at the Environmental Restoration Disposal Facility.
(Photo 3)

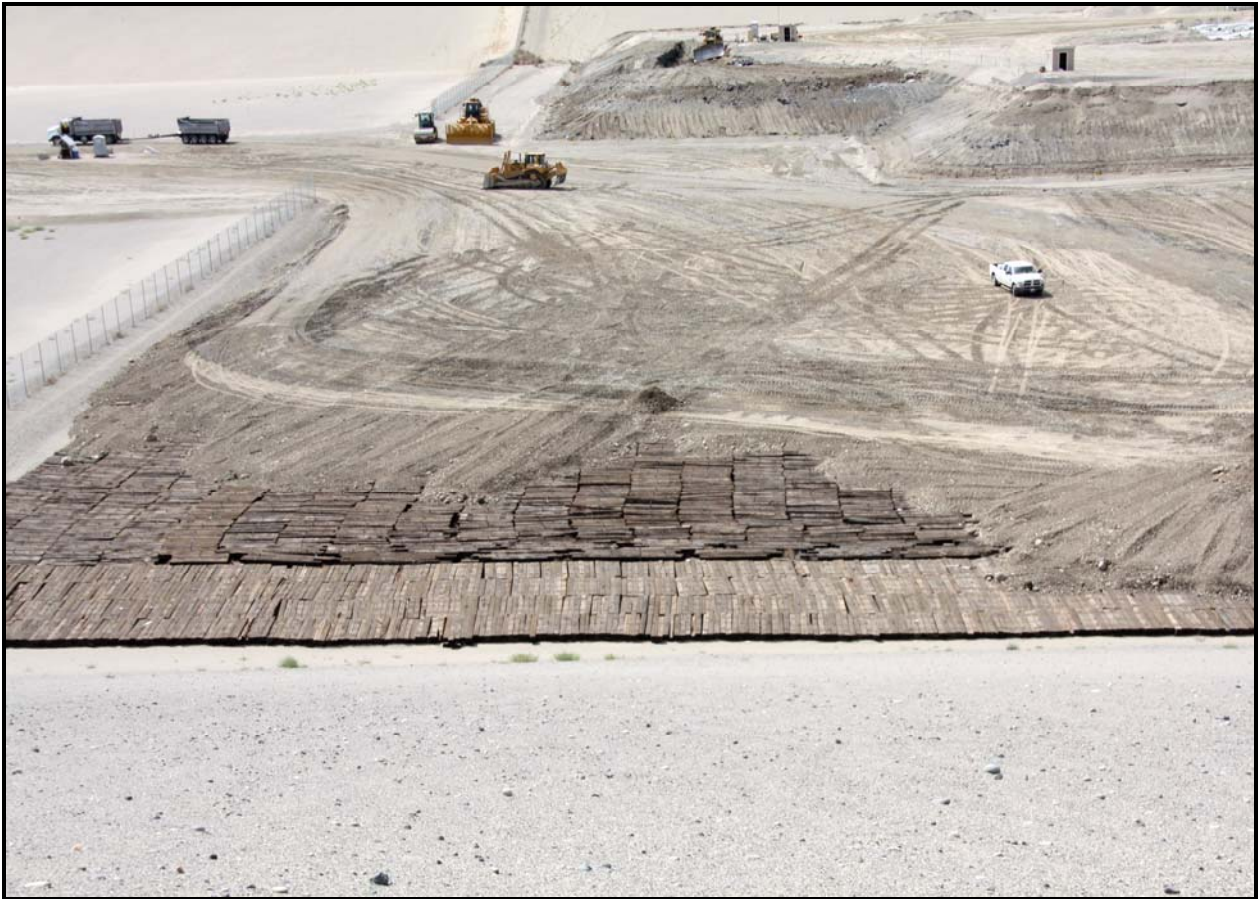
The ERDF disposal team covers nearly 58,500 Hanford Site railroad ties in super cell 9 at the Environmental Restoration Disposal Facility. (Photo 4)

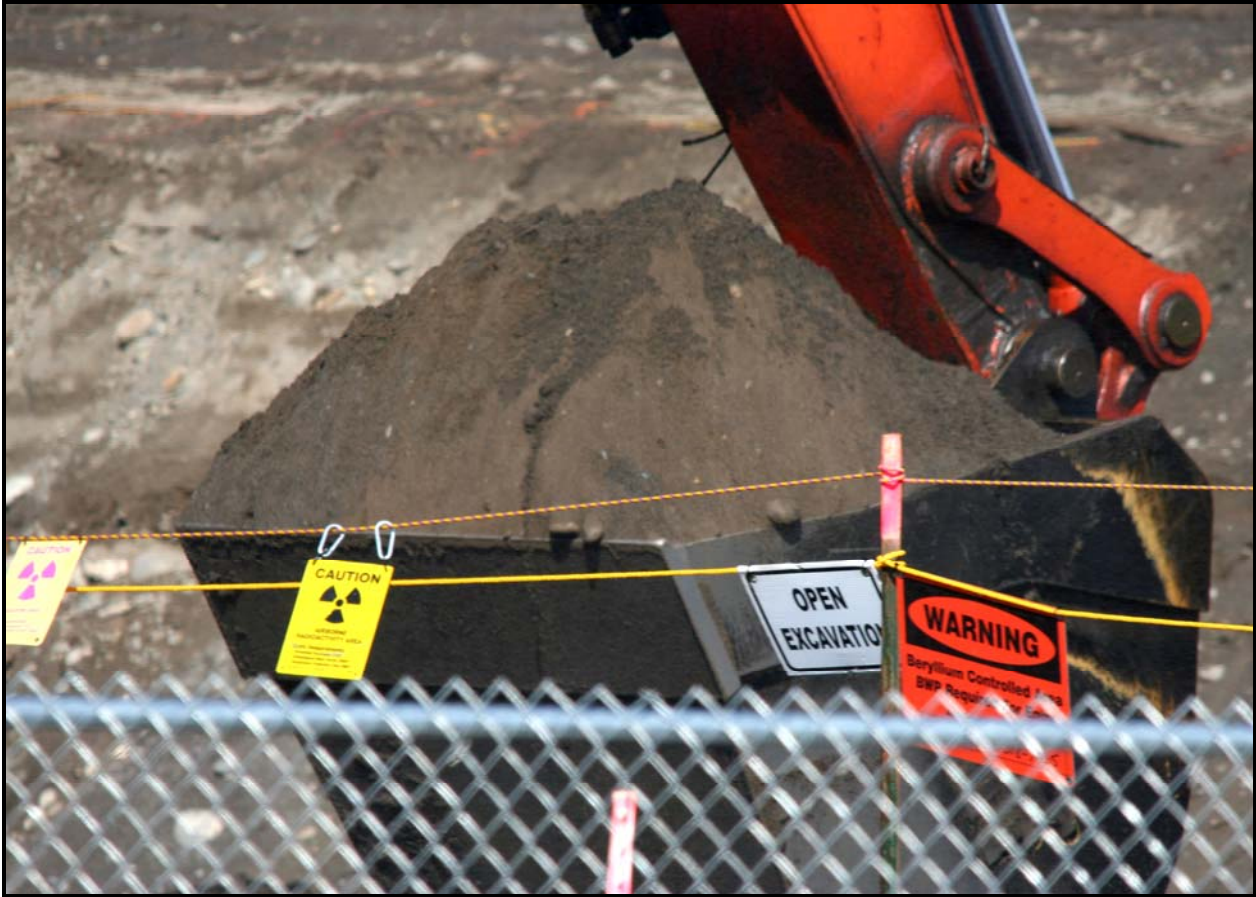
More than 35,000 bank cubic meters have been removed since excavation of the waste trenches began in April. (Photo 6)

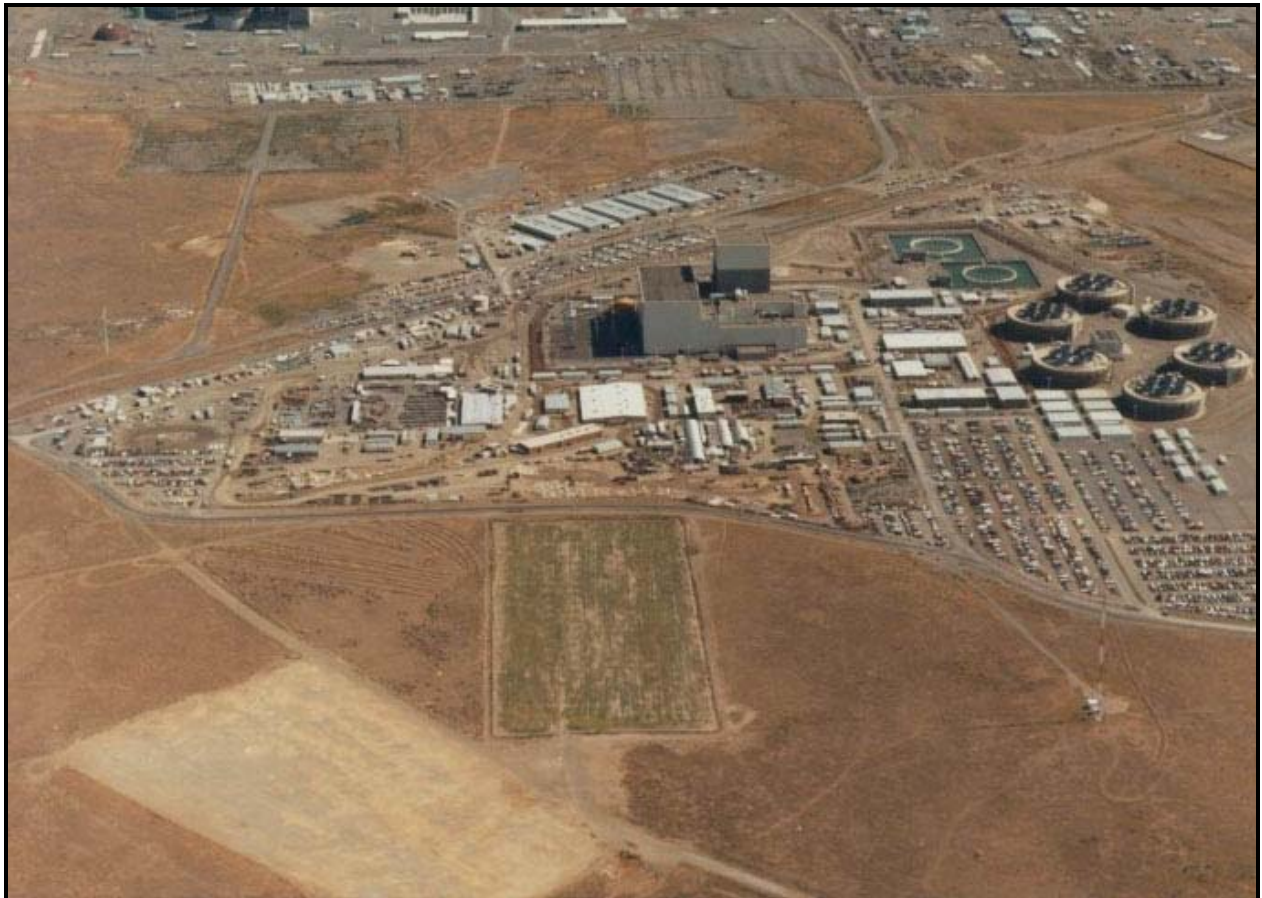
The 618-11 Burial Ground (green rectangle) is adjacent to Columbia Generating Station, an operating nuclear reactor. (Photo 7)
